# Walsh Home Inspections

1 Any St  
Any Town, MA 02111

Prepared for: Your Name

18:03 February 18, 2013

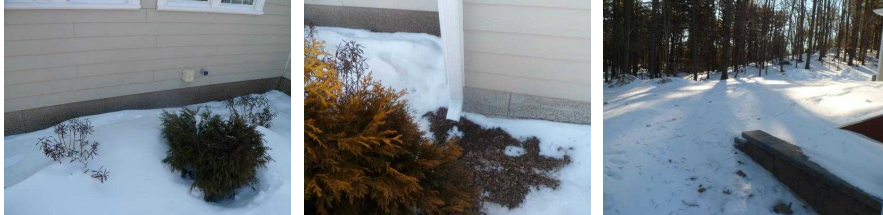
8.      Grading: Minor slope There is a large amount of snow covering the entire grounds. When gone evaluate the grading. Pitch so that the water drains away from the house. Pitch so that the water drains away from the house. Since this is new construction over the first several years the soil will settle, as this happens make sure to re-grade.

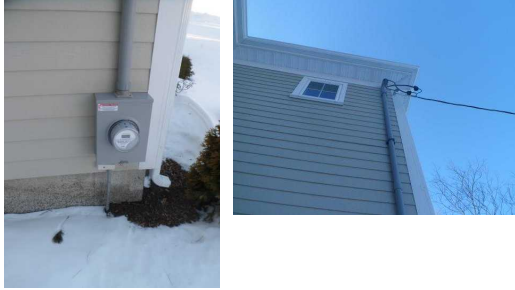
9.      Electrical Mast: Surface mount

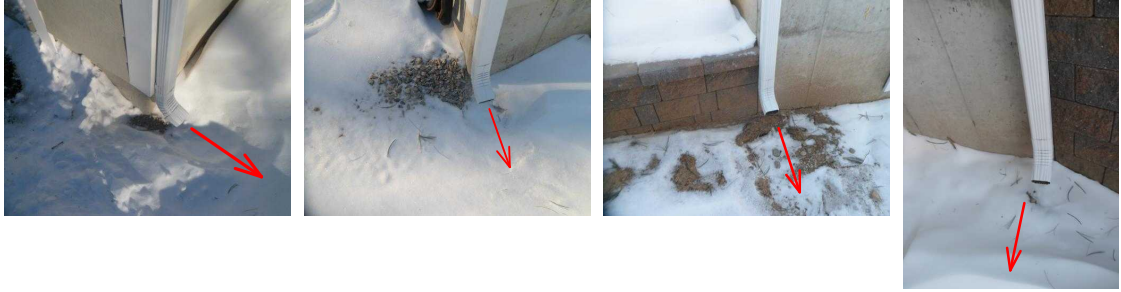
10.      Gutters: Aluminum Suggest cleaning of gutters at least twice per year.  
11.      Downspouts: Aluminum  
12.      Leader/Extension: [Extend runoff drains to move water away from foundation](#)

3. Leader/Extension: [Extend runoff drains to move water away from foundation](#)

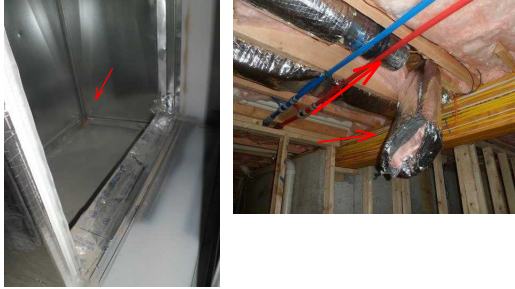
9.      Distribution: Insulated duct, Insulflex duct Suggest having the duct work cleaned. There is a duct for the living room that is capped and not connected. A qualified heating system contractor is recommended to evaluate and estimate repairs

6. Basement Heating System Distribution: Insulated duct, Insulflex duct [Suggest having the duct work cleaned. There is a duct for the living room that is capped and not connected. A qualified heating system contractor is recommended to evaluate and estimate repairs](#)

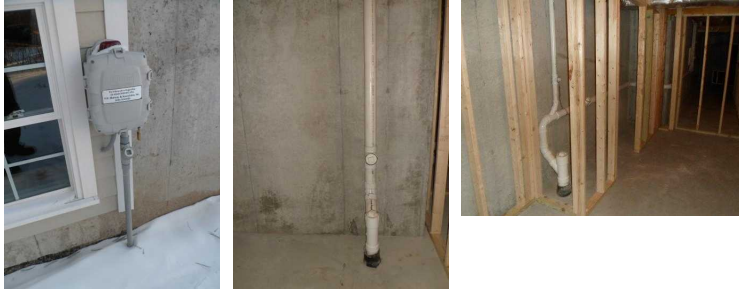
4.      Drain Pipes: PVC Your waste pipe is below the level of the sewer so you have a waste ejector on the outside. This is generally maintenance free, make sure to not use when there is no power.

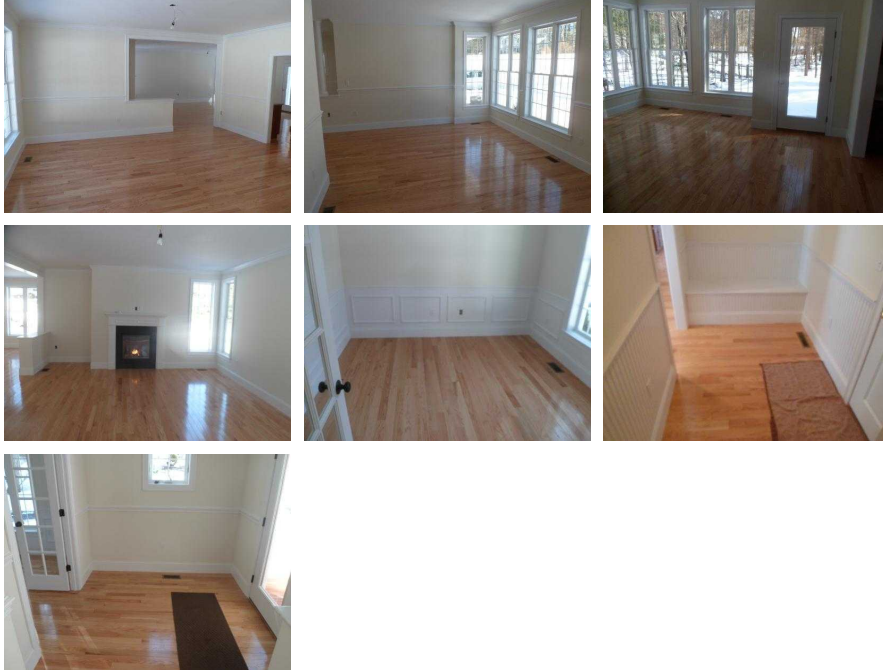
2.      Ceiling: Paint In the dining room there are many defects in the ceiling. This should be repaired. In the family room the ceiling appears to have some spots on the ceiling that looks to be spotty in paint.

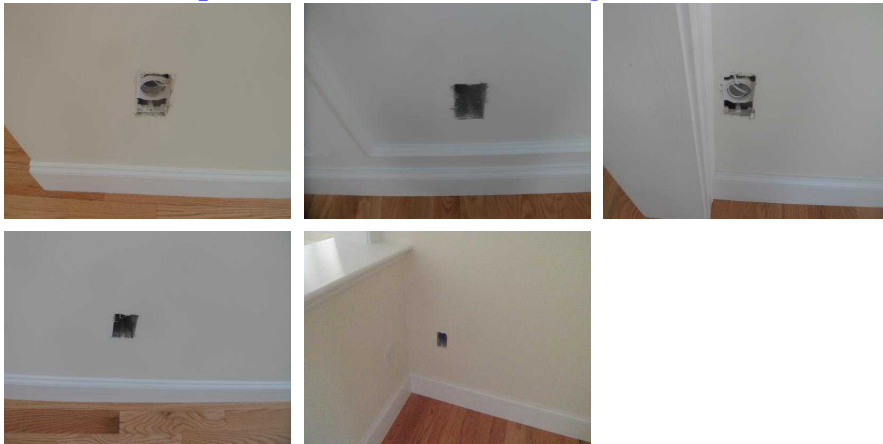
3.      Walls: Paint In the dining room over the right window there is a seam visible, repair. There are missing covers for the central vac.

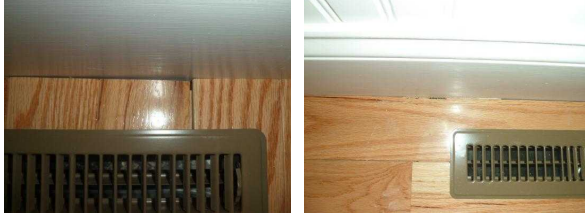
4.      Floor: Hardwood There are a few gaps especially around the vents. These areas may tighten up when some humidity gets into the wood

11. Dining room, Living room, Family room, Office, Hall and Mudroom Living Space Floor: Hardwood **There are a few gaps especially around the vents. These areas may tighten up when some humidity gets into the wood**

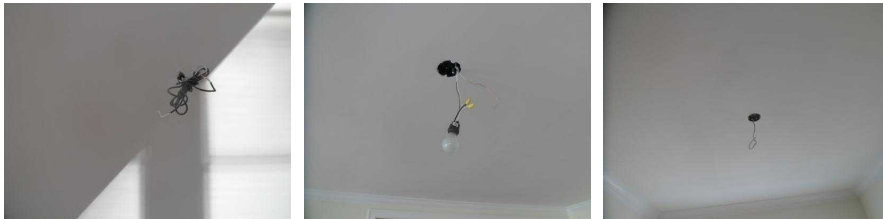
7.      Electrical: 110 VAC Exposed live wires due to missing light fixtures and some detectors.

8. Dining room, Living room, Family room, Office, Hall and Mudroom Living Space Electrical: 110 VAC **Exposed live wires due to missing light fixtures and some detectors.**

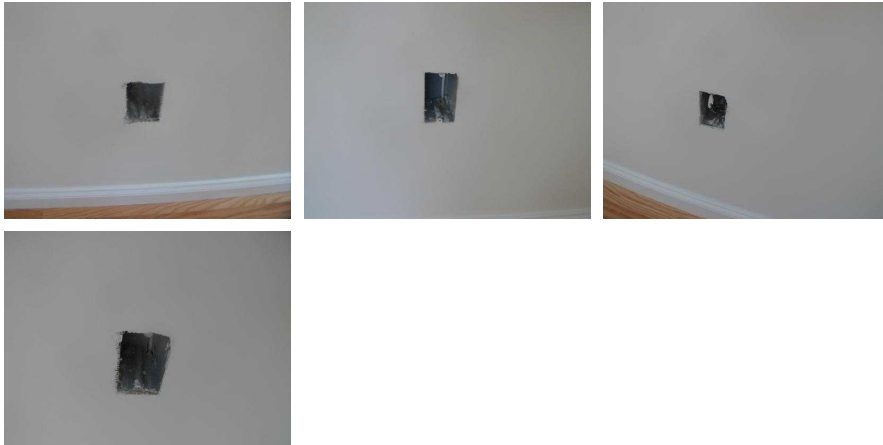
3.      Walls: Paint **There are cover plates missing on the walls.**

13. Bedrooms Bedroom Walls: Paint **There are cover plates missing on the walls.**

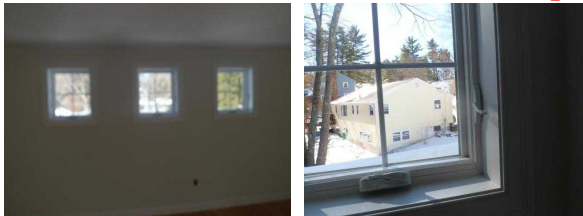
6.      Windows: Vinyl double hung, Vinyl awning **The locks on the awning windows do not work properly, they are either sticking to open or wont close and lock correct. Repair.**

9. Bedrooms Bedroom Windows: Vinyl double hung, Vinyl awning **The locks on the awning windows do not work properly, they are either sticking to open or wont close and lock correct. Repair.**

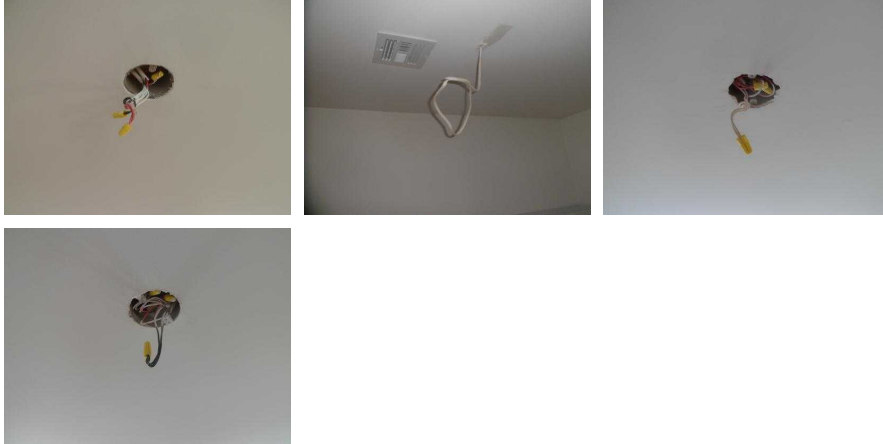
7.      Electrical: 110 VAC **There are light fixtures missing.**

10. Bedrooms Bedroom Electrical: 110 VAC **There are light fixtures missing.**

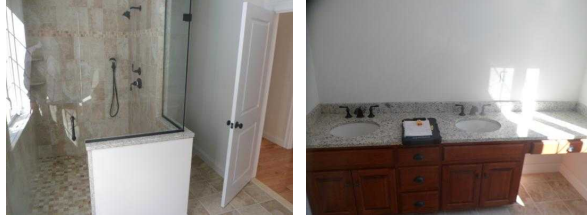
- 17.      Ceiling: Paint
- 18.      Walls: Wood and paint
- 19.      Floor: Hardwood
- 20.      Doors: Hollow wood
- 21.      Windows: Vinyl casement The right window needs to be repaired, will not open and close properly.

11. Master Bathroom Windows: Vinyl casement The right window needs to be repaired, will not open and close properly.

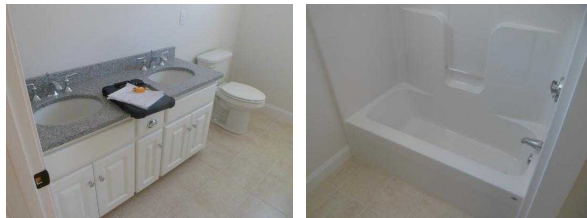
36.      Windows: Vinyl casement **The window needs to be repaired, will not open and close properly.**
37.      Electrical: 110 VAC GFCI
38.      Counter/Cabinet: Wood and granite
39.      Sink/Basin: Porcelain coated
40.      Faucets/Traps: PVC
41.      Tub/Surround: Fiberglass tub and fiberglass surround Caulk all seems inside and out and seal the grout
42.      Spa Tub/Surround:
43.      Toilets: 1 1/2 Gallon Tank
44.      HVAC Source: Forced air
45.      Ventilation: Electric ventilation fan, Window

12. 2nd floor main Bathroom Windows: Vinyl casement The window needs to be repaired, will not open and close properly.

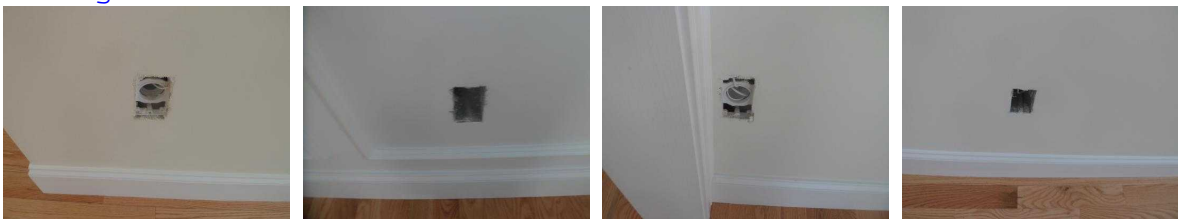
9. Dining room, Living room, Family room, Office, Hall and Mudroom Living Space Ceiling: Paint In the dining room there are many defects in the ceiling. This should be repaired. In the family room the ceiling appears to have some spots on the ceiling that looks to be spotty in paint.
10. Dining room, Living room, Family room, Office, Hall and Mudroom Living Space Walls: Paint In the dining room over the right window there is a seam visible, repair. There are missing covers for the central vac.
