General Information

Property Address 12 Brady Rd

Inspector Name Michael Walsh MA License # 625
Company Name Walsh Home Inspections
Company Address 23 Hammond St
City Providence State RI Zip 02909
Phone 339-298-1124 Fax
E-Mail walshhi@yahoo.com
File Number 050310800mw

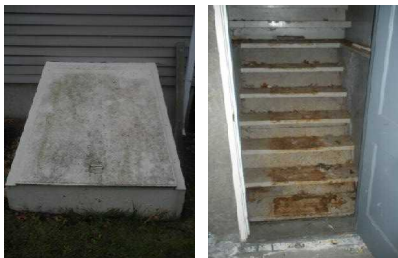
11. Window Wells:
12. Retaining Walls:
13. Basement Stairwell: Metal Keep all seems caulked.

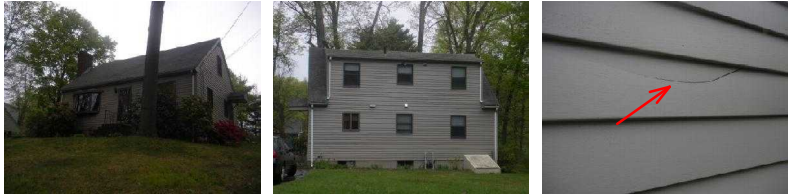
1. Type: Wood There are a few clapboards that are split and should be repaired or sealed. Keep up with the paint.

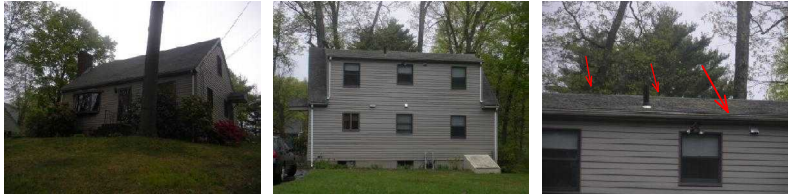
2. Material: Asphalt shingle Appears to have multiple layers, roof has lots of moss and lichen growing on the shingles. This is a sign that you are not getting sunlight on the roof and it is not drying properly. The trees in the front of the house are the general cause of this. have them trimmed and the roof material cleaned.

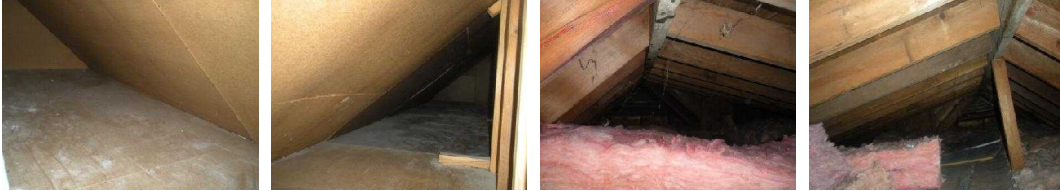
1. Method of Inspection: From the attic access, In the attic
2. Unable to Inspect: 80% This is a Cape with a dormered roof with access to a small portion of the attic and one eave. The eave has been completely finished with material so there is no visible access.

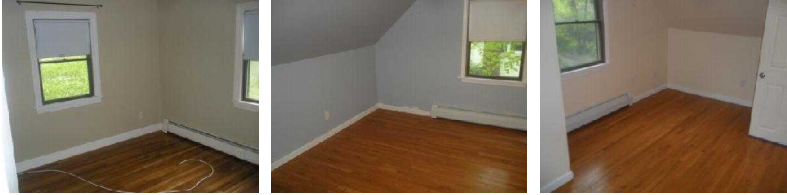
1. Closet: Single

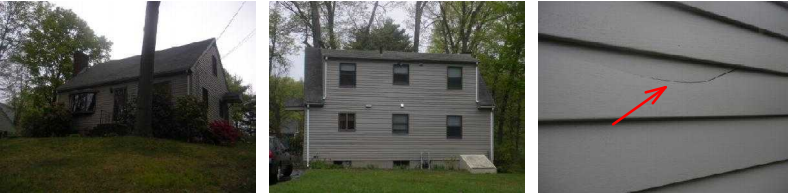
3. Exterior Surface Type: Wood There are a few clapboards that are split and should be repaired or sealed. Keep up with the paint.

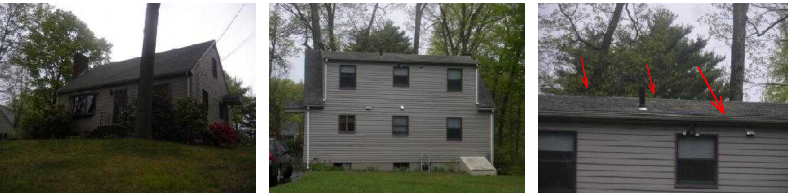
4. Main Roof Surface Material: Asphalt shingle Appears to have multiple layers, roof has lots of moss and lichen growing on the shingles. This is a sign that you are not getting sunlight on the roof and it is not drying properly. The trees in the front of the house are the general cause of this. have them trimmed and the roof material cleaned.

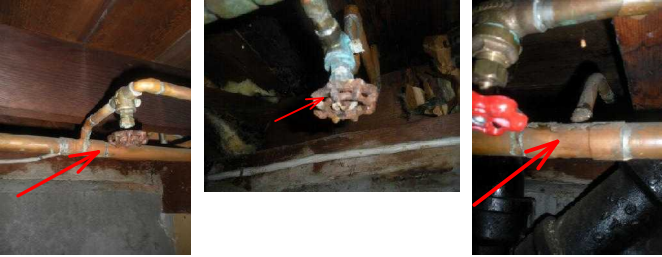
Water Lines: (continued)

6. **Water Lines:** Copper There are several shut off valves with active leaks and one leak in the heating copper that is also active. have a plumber in to repair.

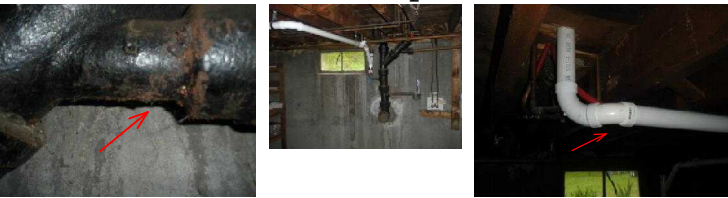
7. Drain Pipes: PVC, cast iron and copper Cast iron is rotted at knuckle, have plumber in to evaluate and make repairs. PVC should be secured better than it is.
